CASE STUDY 4

PARAISO HYDROELECTRIC POWER PLANT

PURAFIL PREVENTS CORROSION AND MONITORS THE ENVIRONMENT

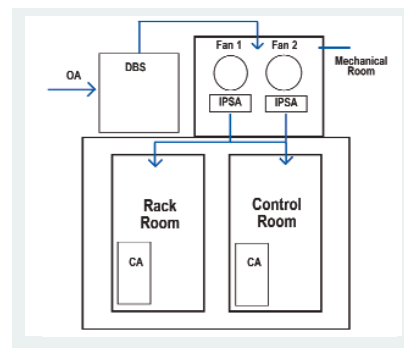
Schematic of Mechanical Room, Control Room, and Rack Room at Paraiso Power Plant:

To solve Paraiso's corrosion problems, Purafil installed a Deep Bed Scrubber adjacent to the mechanical room. The scrubber, housing two stages of Puracarb Media and one stage of Purafil Chemisorbant Media, filters hydrogen sulfide gas from outside ventilation air. To further purify intake air, Purafil installed Side Access Systems, also containing Puracarb Media, downstream of each of the two fans. As a final precaution, Corrosive-Aire Units were installed in the plant's rack and control rooms to maintain low gas levels and provide recirculation air.

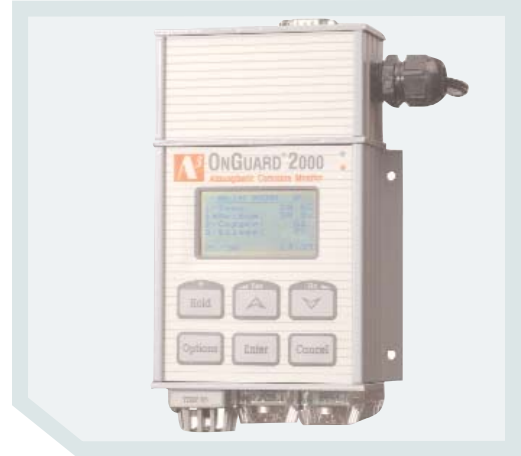
OnGuard Readings at Paraiso Hydroelectric Power Plant, May 20 - June 10, 1997:

In addition to installing Purafil gas-phase air filtration systems, Paraiso also installed two of Purafil's OnGuard 2000 Atmospheric Corrosion Monitors, one in the rack room and one in the control room. The monitors would continuously measure the total corrosion level in each room and correlate the resulting measurements to a G1, G2, G3 or GX ISA severity level.

Twice during the initial 30-day monitoring period, OnGuard alarm indicators warned of a hazardous GX environment. Because Purafil's gas-phase air filtration systems were functioning efficiently, Ing. Mario Carvajal referred to maintenance logs for clues as to what could have caused the problem. The logs revealed that both fans, located in the mechanical room, had been shut down for repair on two separate occasions. For a total of seven days, Purafil's PSAs were unable to prevent corrosive gases from entering the rack and control rooms. Once the fans were repaired, corrosion levels returned to a normal G1 environment.
